**ART End User Applications
Task 2.04.19.06
Supercritical Transformational Electric Power (STEP)**

Milestone Report

Foil Bearing Coating Behavior in CO₂

August 1, 2017

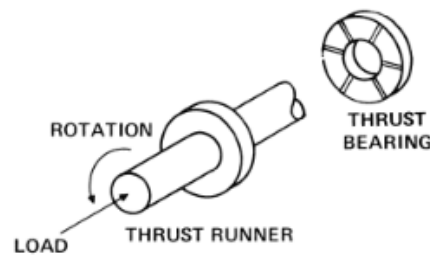
**Figure 1. Two Main Categories of Continuous Rotation Bearings ^[1]**

In a general sense, a bearing is an element or assembly that guides or positions components subject to relative motion. For turbomachinery bearings, continuous rotation is required, and bearings are often classified as radial (journal) or axial (thrust) bearings. These are illustrated graphically in Figure 1, where the name of each derives from the positioning requirement. The fundamental requirement of a bearing is that it maintains the desired relative position, despite the forces or loads that must be transmitted. As such, it is important to minimize the wear which may be created by these surfaces under relative motion and load, and desirable to reduce the parasitic energy losses which invariably accompany bearings.

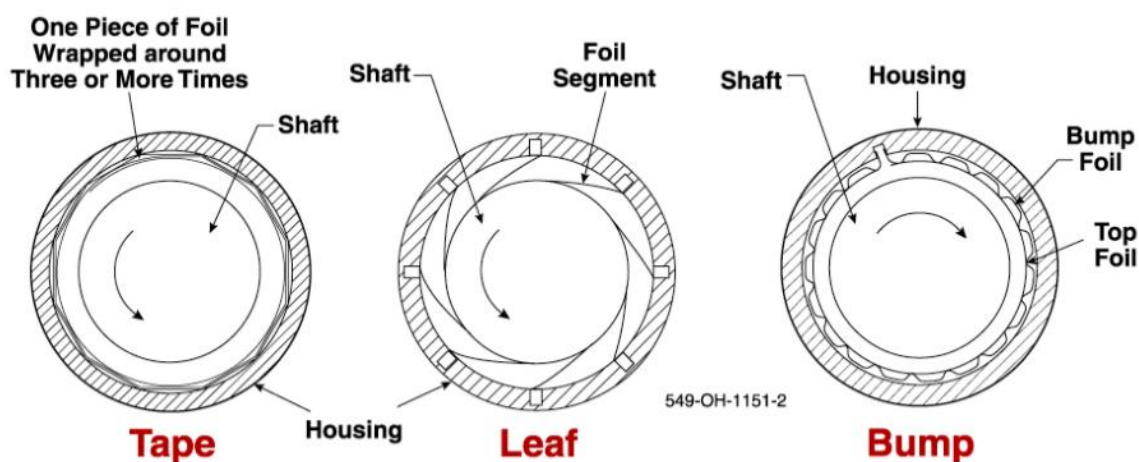
Figure 2. Three types of gas foil radial bearings ^[3]

Among the three type of gas foil bearings shown in Figure 2, the bump type has been the most popular. It is comprised of three basic components: a smooth top foil, a corrugated bottom foil or “bump foil”, and the support structure, usually a cylindrical shell for journal bearings and a flat disc for thrust bearings. Illustrations for these bump type foils are shown in Figure 3. Both the top and bottom foils are made from thin sheets of compliant metal, typically a nickel-based alloy such as Inconel X750. In a typical configuration, the top foil is affixed to the bearing housing at a point, and is initially allowed to sit to the height of its bump understructure. During loading and running, the foils are perturbed by the film pressure profile and resultant deflection of the foil bearing.

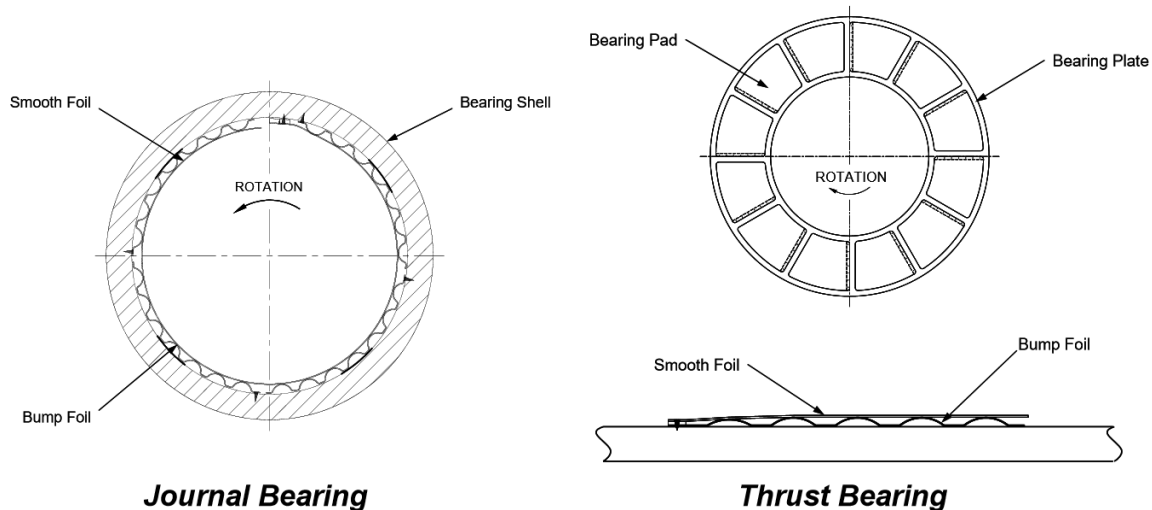
Figure 3. Typical construction for bump foil journal and thrust bearings ^[3]

facilitate rotation during these periods, coatings are applied to the top foil, the shaft journal, or both to minimize friction and wear. Important requirements for these surface coatings include chemical compatibility with the fluid environment, surface properties (surface roughness, coefficient of friction, etc.) to minimize abrasive wear and particle debris generation, and good adhesion to the metal substrate.

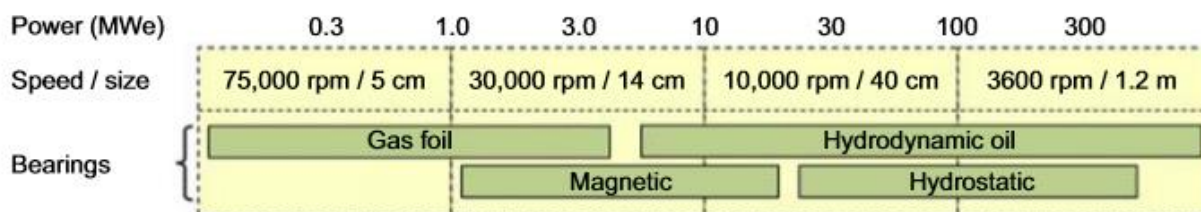
Figure 4. Types of bearings proposed for use in S-CO₂ applications across range of rotor power ^[2]

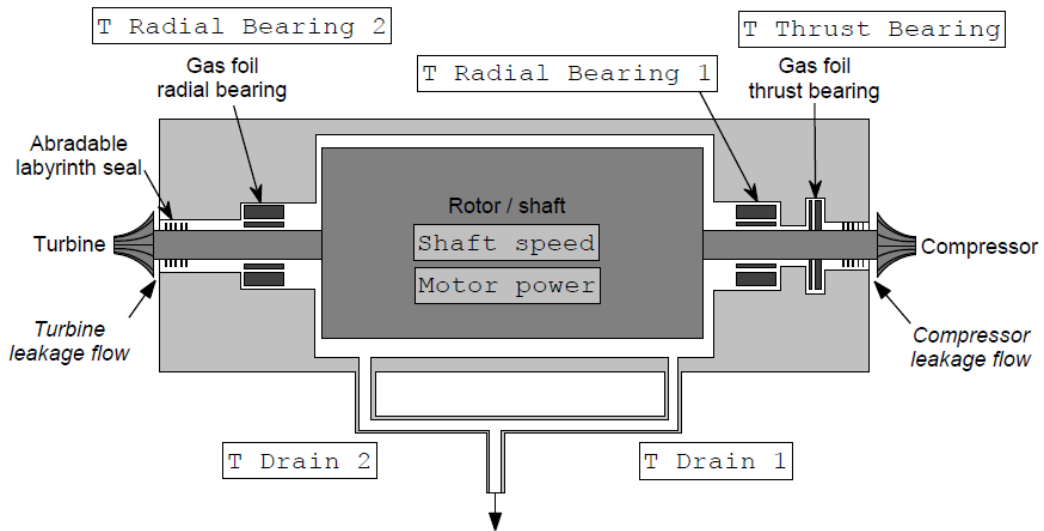
Figure 5. Diagram of Sandia's S-CO₂ TAC showing the location for the bearings

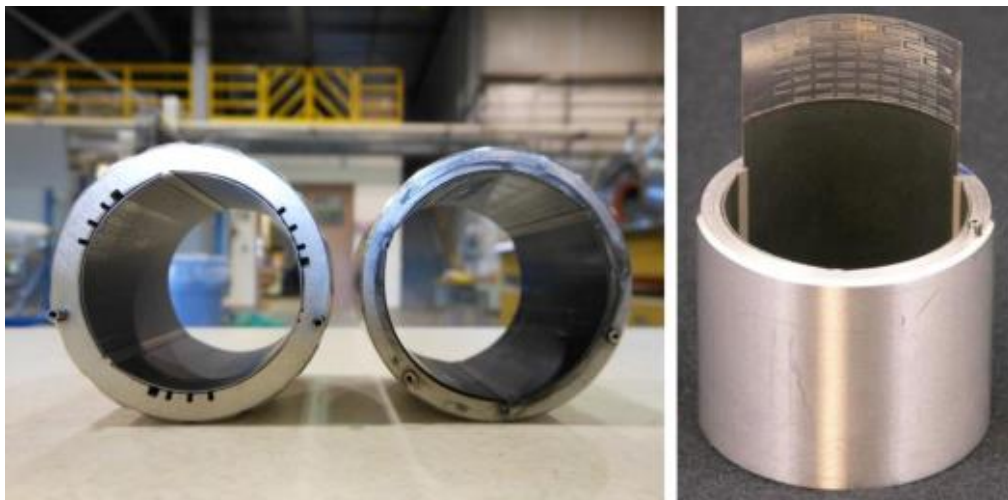
Figure 6. Images of the gas foil radial (journal) bearings used in Sandia's S-CO₂ RCBC loop

The journal bearings were obtained off-the-shelf from Capstone. These are approximately 2" long and 1.5" in diameter and have different solid lubricant coatings for the turbine and compressor sides of the TAC. The high temperature turbine side journal bearing uses a patented Capstone coating material with an upper temperature limit of 538°C (1000°F), while the compressor end journal bearing uses a Teflon-based coating capable of reaching temperatures of 232°C (450°F). In both cases the foil themselves are made from Inconel X750. Several images of these gas foil journal bearings are shown in Figure 6.

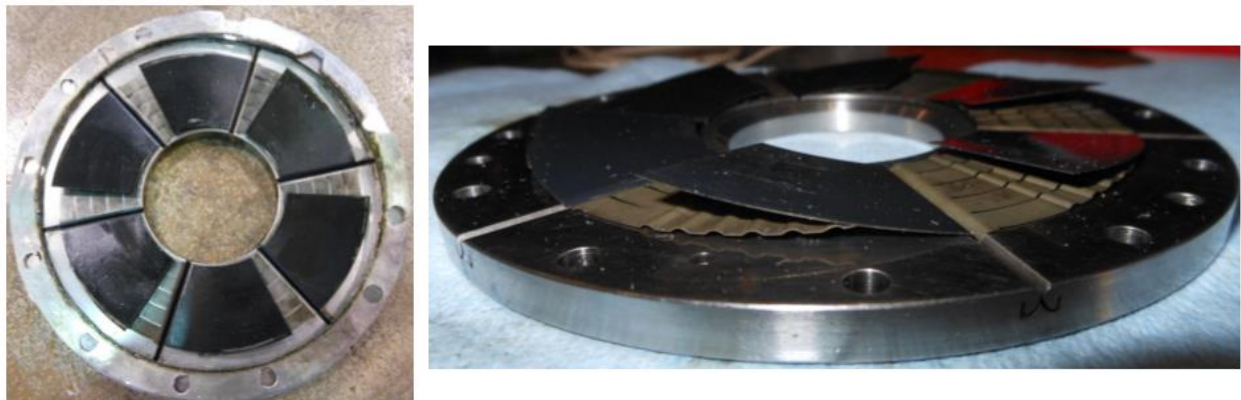
Figure 7. Images of the gas foil axial (thrust) bearing used in Sandia's S-CO₂ RCBC loop

Design uncertainties for foil journal bearings were minor compared to those for the foil thrust bearings. No commercial manufacturer was identified to deliver a foil thrust bearing, therefore they were designed and built in-house at Barber-Nichols from open source information provided by NASA Glenn Research Center. Based on NASA's experience, a foil thrust bearing was developed which was 4" outer diameter, 2" internal diameter, and featured 6 pads. The foils themselves were made from Inconel X750, and a Teflon coating was applied as the foil coating material. Several images of a gas foil thrust bearing are shown in Figure 7.

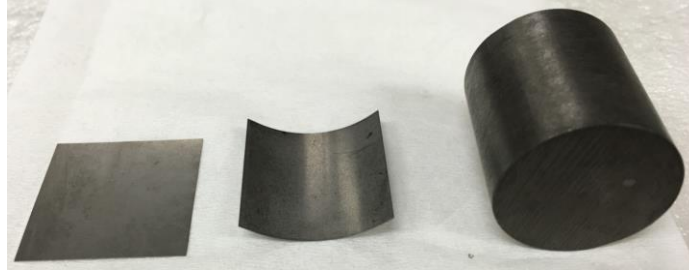
Figure 8. Sample formats used for gas foil bearing performance evaluations

Xdot worked with four separate coating vendors to provide a series of 6 different coatings for evaluation. Being involved in bearing design, it was very important to Xdot that the coating be evaluated in the format that it will be used in a real bearing. To achieve this, they provided samples for each of the coatings across a range of possible formats. The different sample formats included flat foil, rolled or curved foil, and cylindrical; these are shown in Figure 8. In each case the coating material was applied to the sample surface. The flat foils were included to represent the thrust bearing foils, while the curved foils represent those for the journal bearing. The cylindrical samples represent a case where the coating is applied to the rotating shaft itself rather than to the bearing foils.

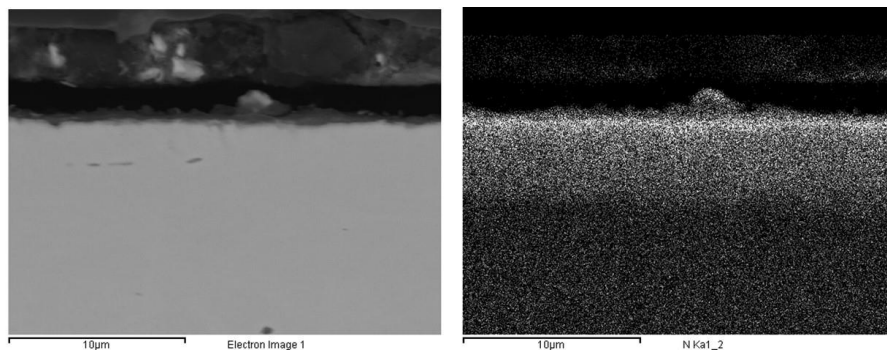
Figure 9. SEM images of a sample with the TX1 nitride surface treatment

TURBOCAM International (Dover, NH) was a third coating vendor. Their TX1 surface treatment differed versus all of the other materials investigated, as this was not a coating, but rather a metal surface treatment process (nitride) imposed on the surface. Two images are shown in Figure 9 for this surface treatment; the image on the left is a microscope image for the material surface cross-section and on the right is an EDS map of nitrogen for the same cross-section area. This shows the presence of nitrogen at the sample surface area, which imparts hardness, wear resistance, and lubricity to the surface. TX1 was evaluated at both of the exposure conditions in all three sample formats. The substrate material was now 1" x 1" 316 stainless steel rather than Inconel X750, due to the requirements for the surface treatment process. For both the flat and curved foil samples, samples were evaluated for three separate vendor applications of the surface treatment. These samples are designated as treatments A, B, and C, and the parameters of the surface treatment process differed slightly among the three.

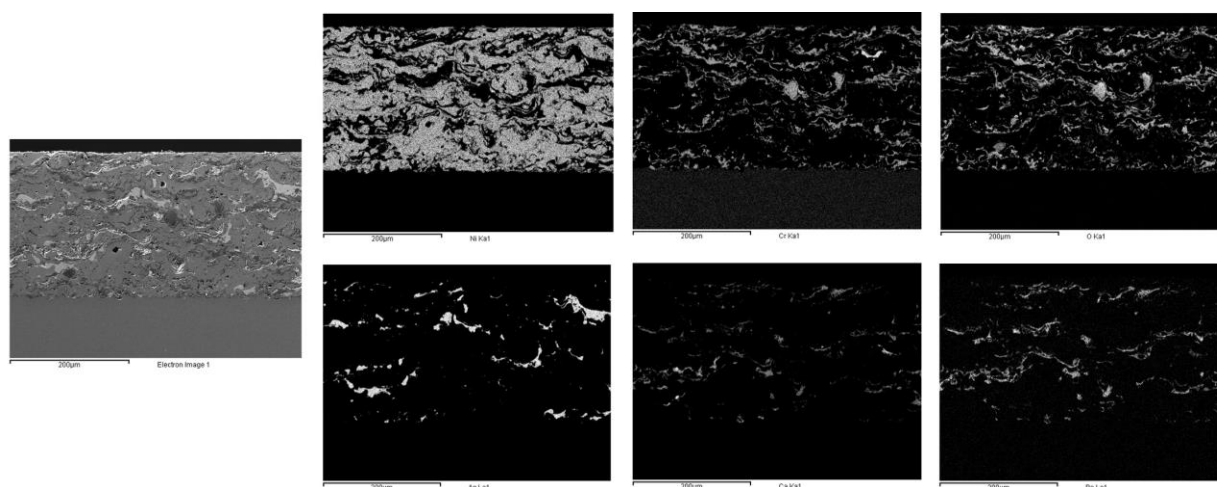
Figure 10. EDS chemical analysis for the PS400 coating

A final coating was the NASA developed PS400 material, which is provided by Hohman Plating and Manufacturing (Dayton, OH). This material, being applied to the metal surface by plasma spray, was provided onto thicker metal substrates (0.125") of 1.25" x 1.25" 15-5 stainless steel. In an actual bearing application, it would likely be applied to the thrust runner disk surface or shaft, rather than to the bearing foils. It was evaluated in this thicker plate format at both of the exposure conditions. PS400 is the latest in a long line of plasma-sprayed solid lubricant coatings dating back to the 1970s, all developed at NASA Glenn Research Center^[9,10]. It is comprised of a nickel-molybdenum-aluminum binder with added chromium oxide, silver, and barium-calcium fluoride. The silver and barium-calcium-fluoride (5% by mass) provide the solid lubrication, while chromium oxide (25%) is used as a hardener, and nickel-moly-aluminum (70%) is tough binder matrix to stabilize the solid layer. A coating cross-section chemical analysis for this material is shown in Figure 10. Compared to the previous generation coating PS304, it has higher density, smoother finish, better stability, good creep resistance, strength, oxidative and dimensional stability. Solid lubricant content was halved from 10wt% to 5 for PS400 as compared to its predecessor. Total coating thickness of at least 300 μm , is built up layer by layer in many separate plasma spray passes.

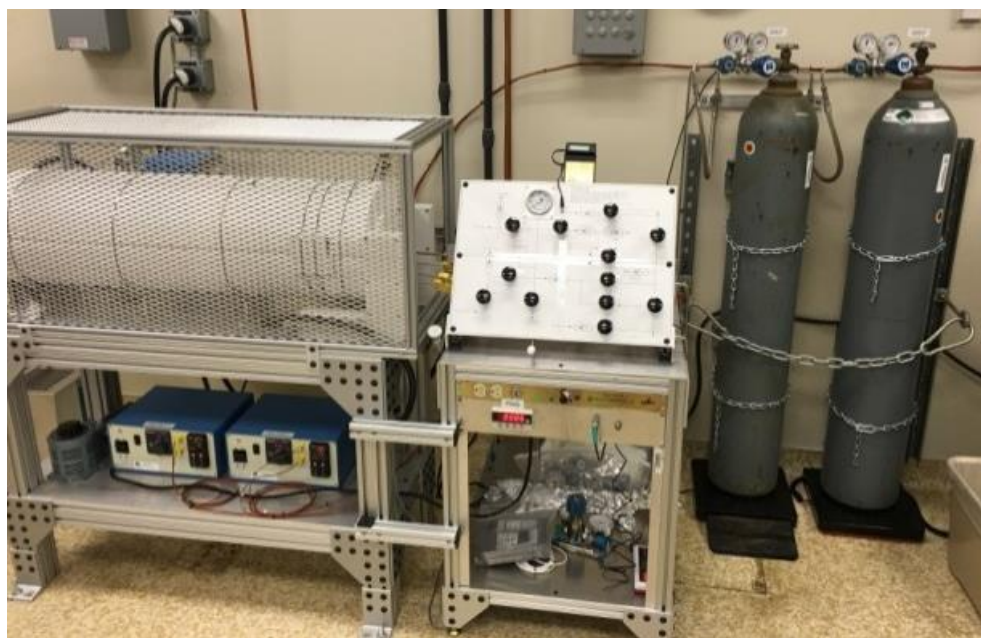
Figure 11. Modified autoclave furnace for gas foil bearing tests at 300psi CO₂

The test configuration for these evaluations was established using the high temperature autoclave furnace that was used previously for the carbon steel S-CO₂ corrosion study^[11]; this is located at the laboratory in Livermore, CA. The furnace itself was modified to allow for tests in a controlled atmosphere of 300 psi CO₂, instead of in S-CO₂. While the pressure is maintained at 300 psi, the setup allows for a flow of fresh CO₂ through its chamber. Temperature of the internal chamber is measured across its length in three locations. A photo of the furnace setup for these tests is shown in Figure 11.

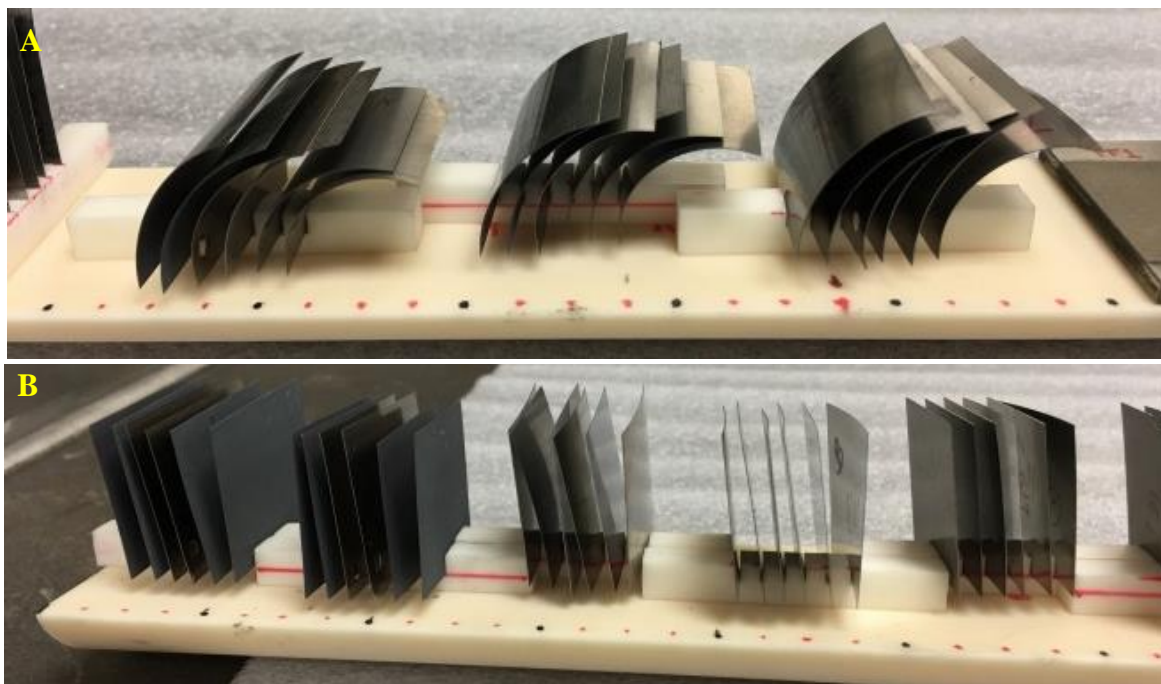
Figure 12. Sample holder configuration used for curved foil samples (A) and flat foil samples (B)

A new sample holder approach was designed for use in these experiments. This was an important aspect to this work, as there were many different sample types and formats to include in each of the tests; each test included over 60 samples. The approach that was developed involved the use of an aluminum oxide ceramic platform (D-Tube), on which the samples were oriented using machined aluminum oxide ceramic sample holders. Samples were oriented within the holders using machined notches spaced along their length. In the case of the thicker samples (PS400) and cylindrical samples, these were placed directly onto the ceramic platform rather than in a machined sample holder. The photos in Figure 11 show how the holder was utilized for the curved foil (A) and flat foil (B) samples, while the photo in Figure 12 shows how the holder was utilized for the full suite of samples in a single test. The dimensions for the holder were 13" long and 1.5" wide, and the height was such that the samples were positioned at the vertical center of the furnace.

Information for each of the coating materials investigated through this set of experiments are summarized in Table 2. Pertinent information for the materials from both Xdot and Mechanical Solutions are included, along with the available information for the “baseline” bearing materials currently used in the Sandia RCBC system. Images for each of the sample types included in the higher temperature exposure test (550°C) are shown in Figure 14, while images for those included in the lower temperature test (315°C) are shown in Figure 15. In the case of the samples in the top two rows, samples are shown in both the flat (top) and curved (bottom) formats.

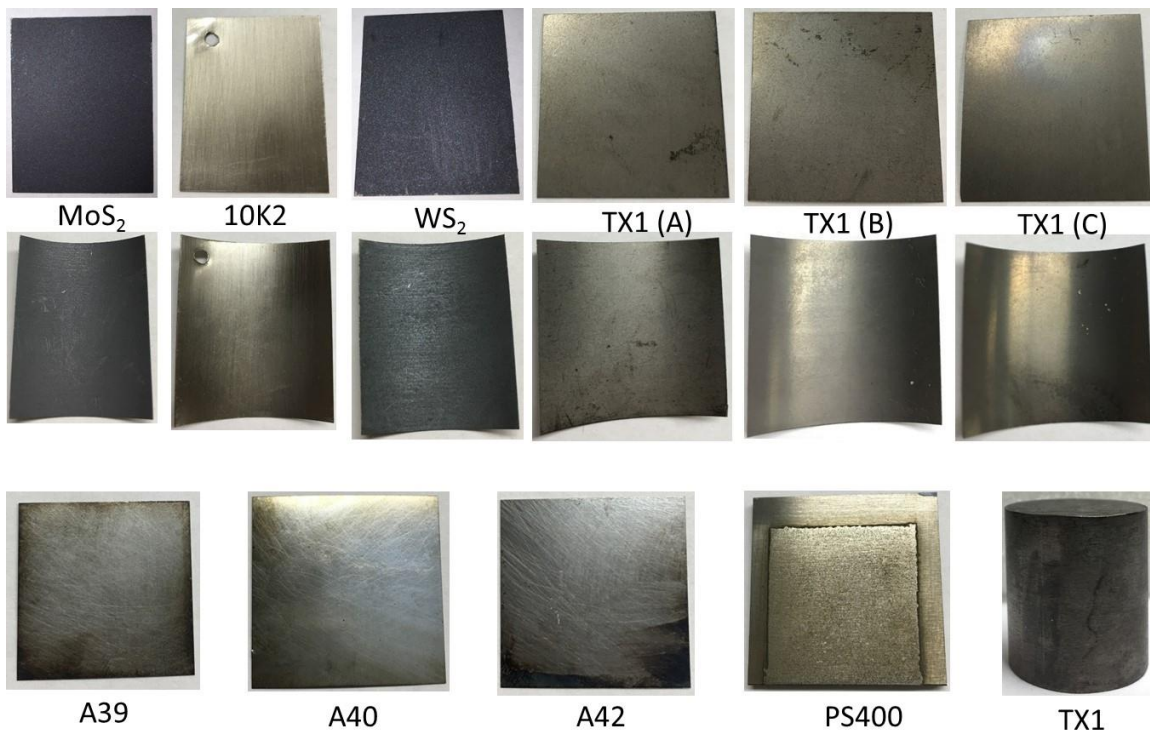
Figure 14. Sample types included in the higher temperature (550°C) exposure test

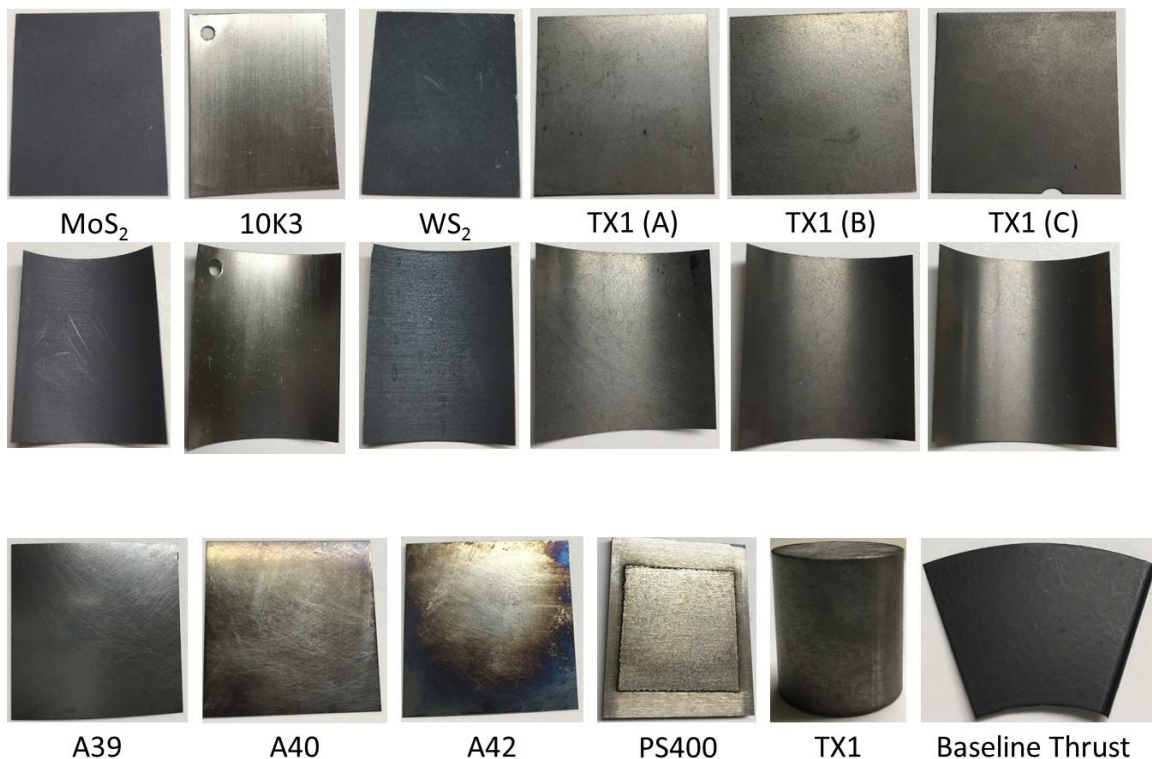
Figure 15. Sample types included in the lower temperature (315°C) exposure test

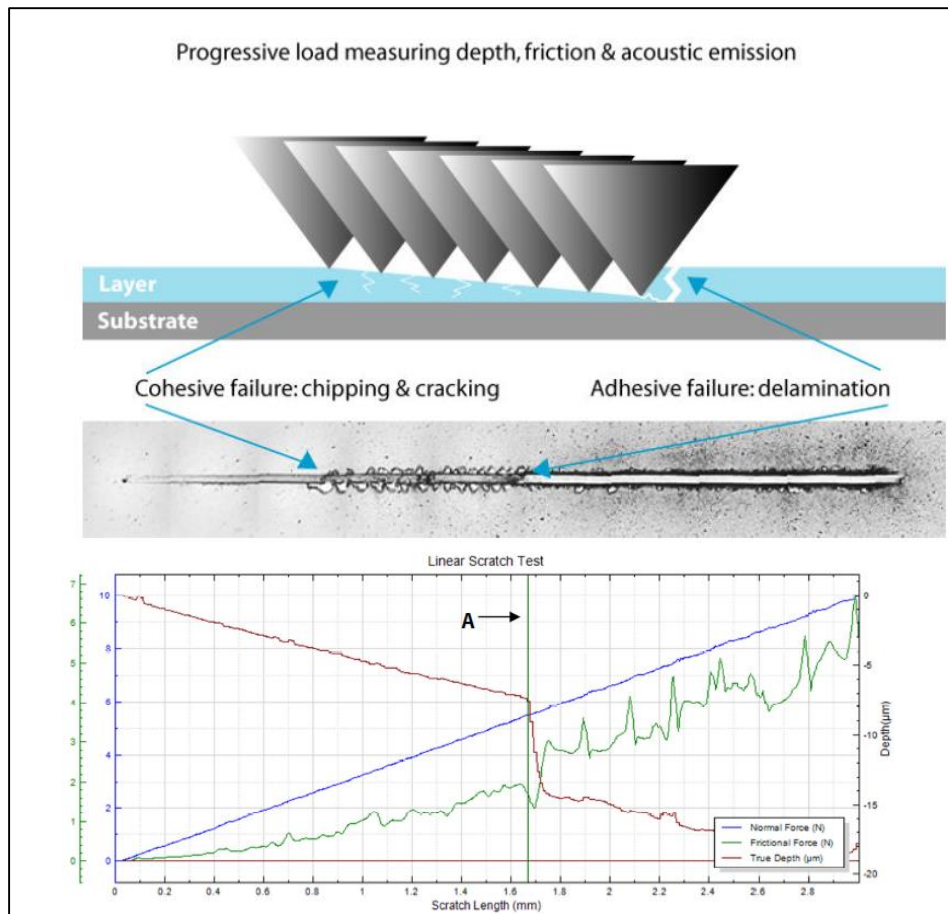
Figure 17. Illustration of multiple elements to instrumented scratch testing

In this test method, a diamond stylus of defined geometry is drawn across the flat surface of a coated test specimen at a constant speed and defined normal force (progressively increasing) for a defined distance. The damage along the scratch track is microscopically assessed as a function of the applied force. This technique is able to differentiate between cohesive failure within the coating (coating scratch damage resistance) and adhesive failure at the interface of the coating-substrate system (coating adhesion strength).

This test method is illustrated in Figure 17. Here, several pieces of information are brought together to demonstrate the method. The drawing at the top illustrates the damage that occurs to the coating material as the stylus moves across the surface. The two types of coating failure, cohesive and adhesive, are indicated here. Below this is a microscopic image of the sample surface. Again, the two distinct types of coating failure are indicated. The visual differences between these types of failure are used to indicate when these occur for a test sample. Finally, at the bottom is a chart indicating the applied normal force (blue), the resulting frictional force (green) and stylus penetration depth (red) across the length of the scratch. The microscopic image together with the chart are used to identify the force at which the two types of failure occur for a sample.

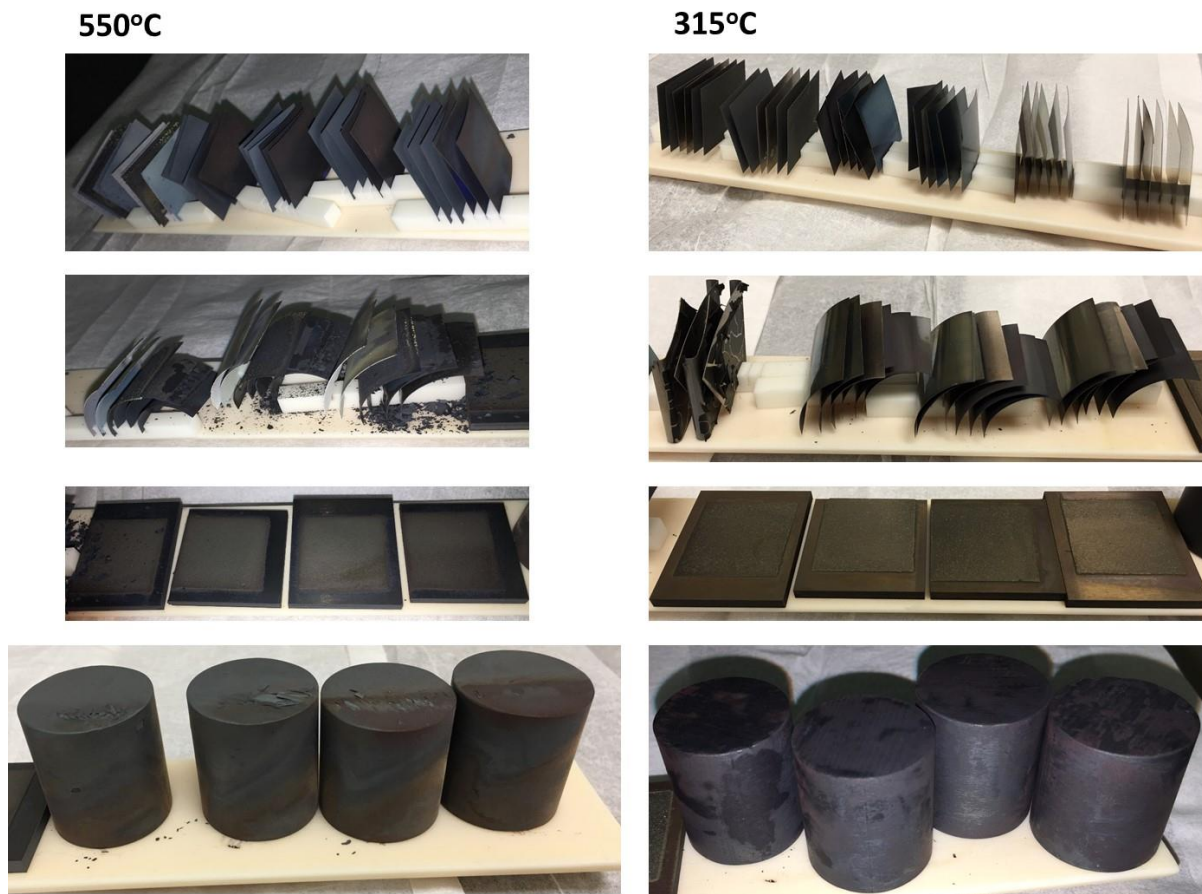
Figure 18. Samples on the holder following the two exposure experiments (550°C and 315°C)

The newly developed sample holder was found to work well for both exposure experiments, allowing for a large number samples of different formats in each test. Photos were taken of the samples on the holder after being removed from the autoclave furnace. These are shown for the two experiments in Figure 18. For the higher temperature exposure (550°C), the most notable observation was the spallation for some of the curved foil samples. This was only observed for the samples with the TX1 surface treatment, and only for the samples in the curved foil and cylinder formats. In the case of the lower temperature test (315°C), the most notable visible feature was the cracking observed for the Baseline Thrust Bearing flat foil sample.

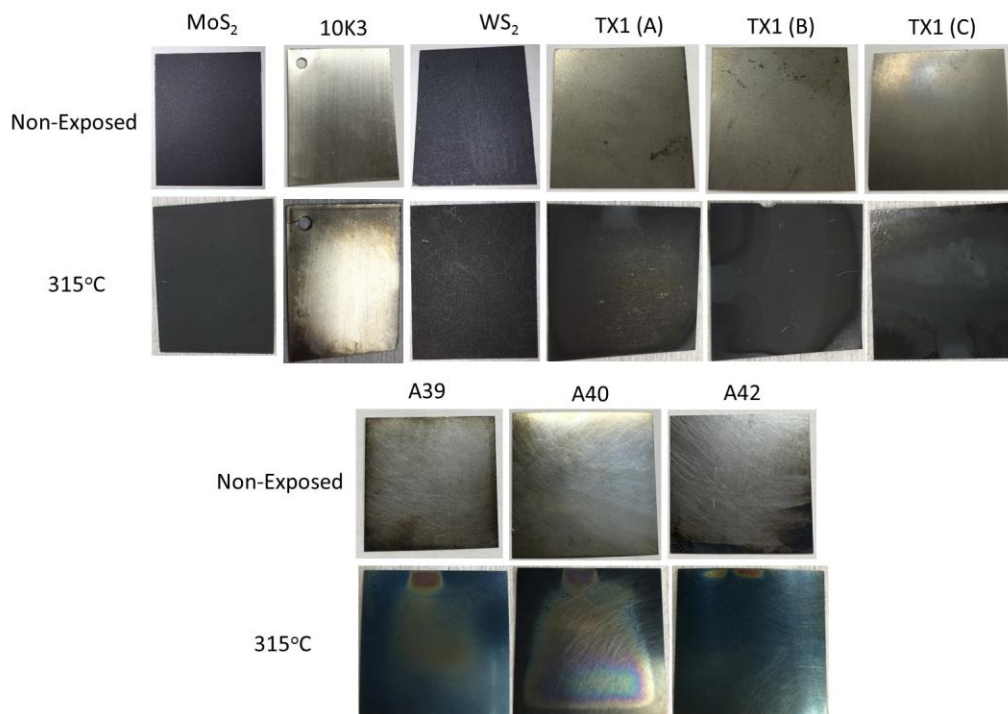
Figure 19. Visual changes for flat foil samples before and after the 315°C exposure test

The sample appearances were observed to change very little following the lower temperature exposure. The samples with the TX1 surface treatment appeared to be darker following the test, resulting from surface oxidation. The Mechanical Solutions samples (A39, A40, A42) had a bluish surface coloring after exposure that was not present prior to this. The Baseline Thrust Bearing foil sample showed the most significant change following the exposure test. The surface was found to have formed many very large cracks, with areas of coating delamination. These have not been observed previously in the operation of the Sandia RCBC, and so this may indicate that the exposure test temperature of 315°C is higher than the actual case in the RCBC system compressor thrust bearing. Lastly, nothing really stood out about the curved sample formats in this test versus those in the flat format.

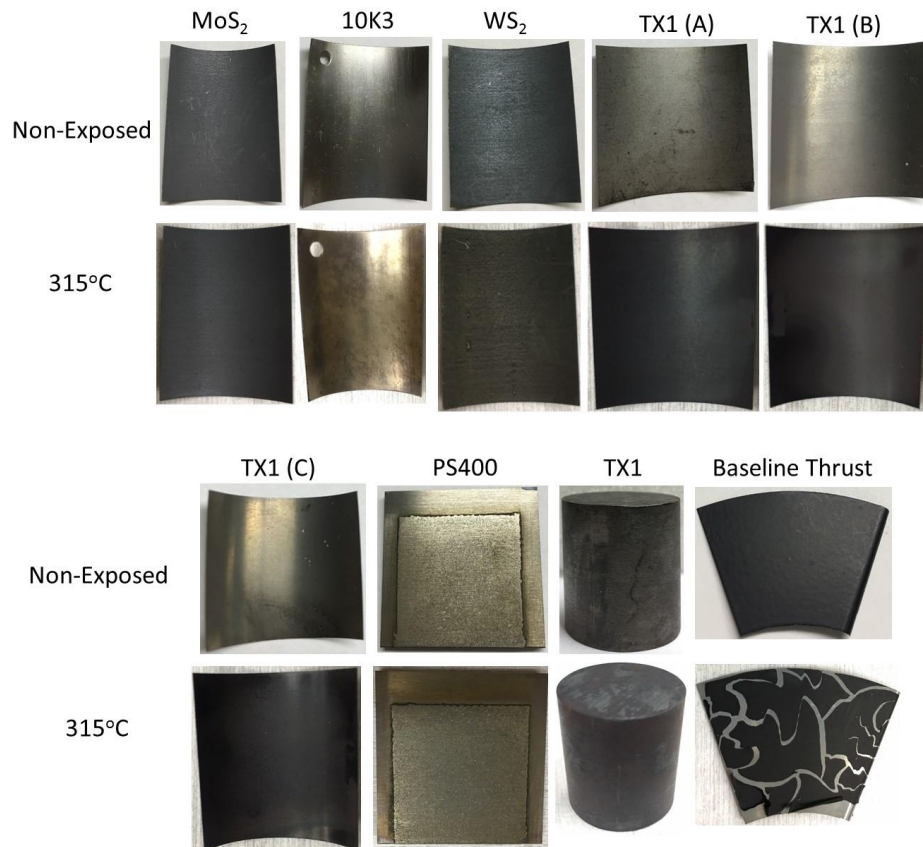
Figure 20. Visual changes for non-flat foil samples before and after the 315°C exposure test

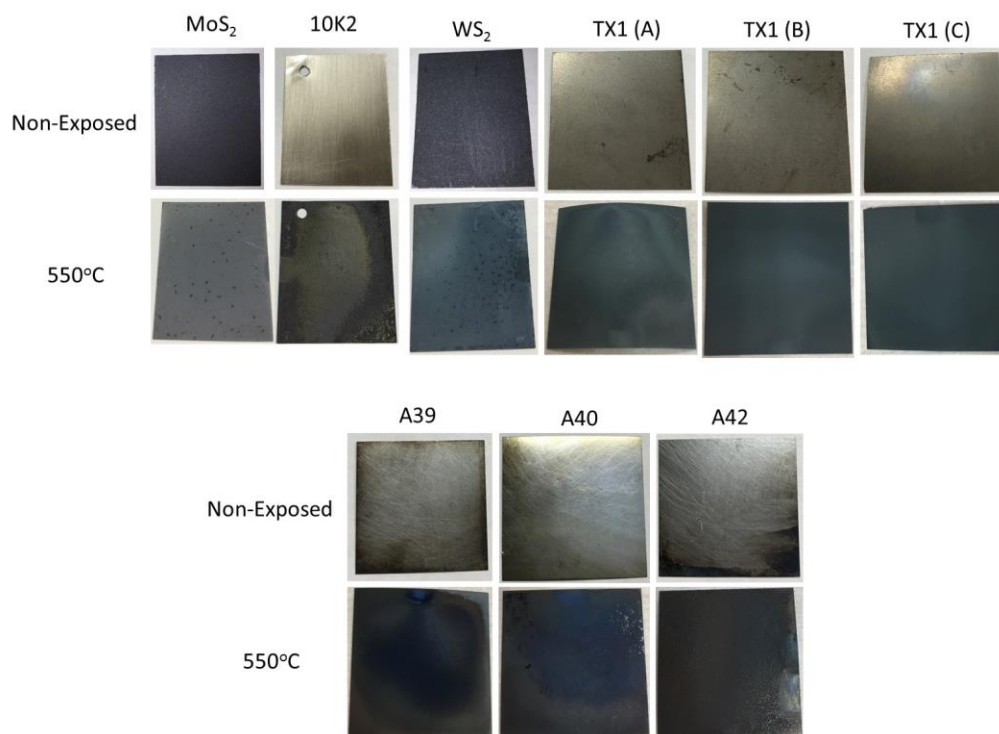
Figure 21. Visual changes for flat foil samples before and after the 550°C exposure test

Following the higher temperature exposure, sample appearances were observed to change more dramatically. The one exception being the PS400 sample, which only appeared slightly darker than in the pre-exposed condition. The most concerning of the changes was observed for the TX1 samples, where significant surface oxidation was observed, along with extensive spallation for those with the curved surfaces. While other types of samples had modified surface coloring after the exposure, all of the coatings appeared to remain intact on the foil samples without obvious cracking and spallation.

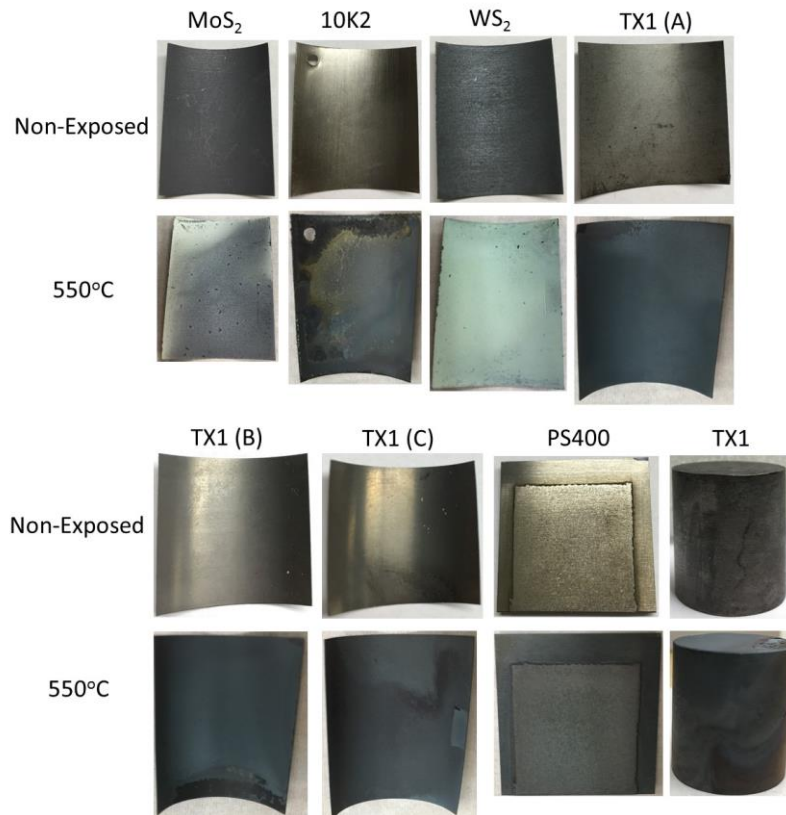
Figure 22. Visual changes for non-flat foil samples before and after the 550°C exposure test

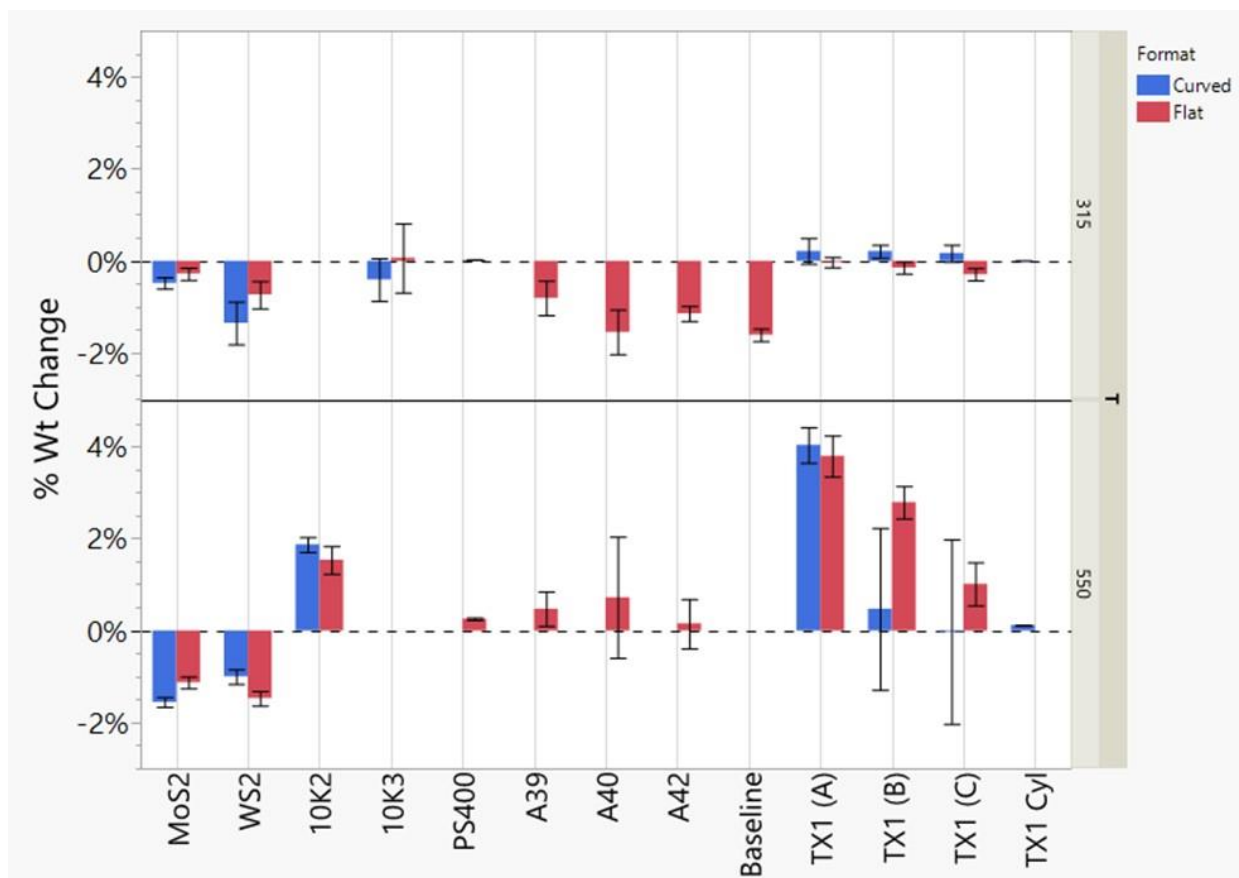
Figure 23. Sample weight changes following the exposure tests at 315°C and 550°C

Changes in sample weight following the exposure experiments can provide insight into their interactions with the environment. The most desirable scenario would be modest changes in sample weight. Weight change data are shown in Figure 23 for both of the exposure tests. Here, for the various types of coating, data are broken out by sample format (curved versus flat) in order to evaluate its influence on sample weight change. Data is reported as percentage weight gain versus the initial sample weight prior to exposure.

For the MoS_2 and WS_2 samples, weight loss was observed, and this appears to increase in moving to the higher exposure temperature. Other than these samples, all of the others exhibited weight gains at the higher temperature. This is believed to be associated to oxidation that has occurred at the interface of the alloy substrate to the coating; this is confirmed by microstructural analyses of samples. Worth noting, is that the samples with the largest weight gains were the 10K2 and TX1 samples.

For the case of the lower temperature exposure, many samples exhibited weight loss, and only the TX1 samples had gained weight. Samples with the most significant weight loss were the Mechanical Solutions samples (A39, A40, A42) along with the baseline thrust bearing foil. It is not clear why sample weight loss was much more common at the lower exposure temperature.

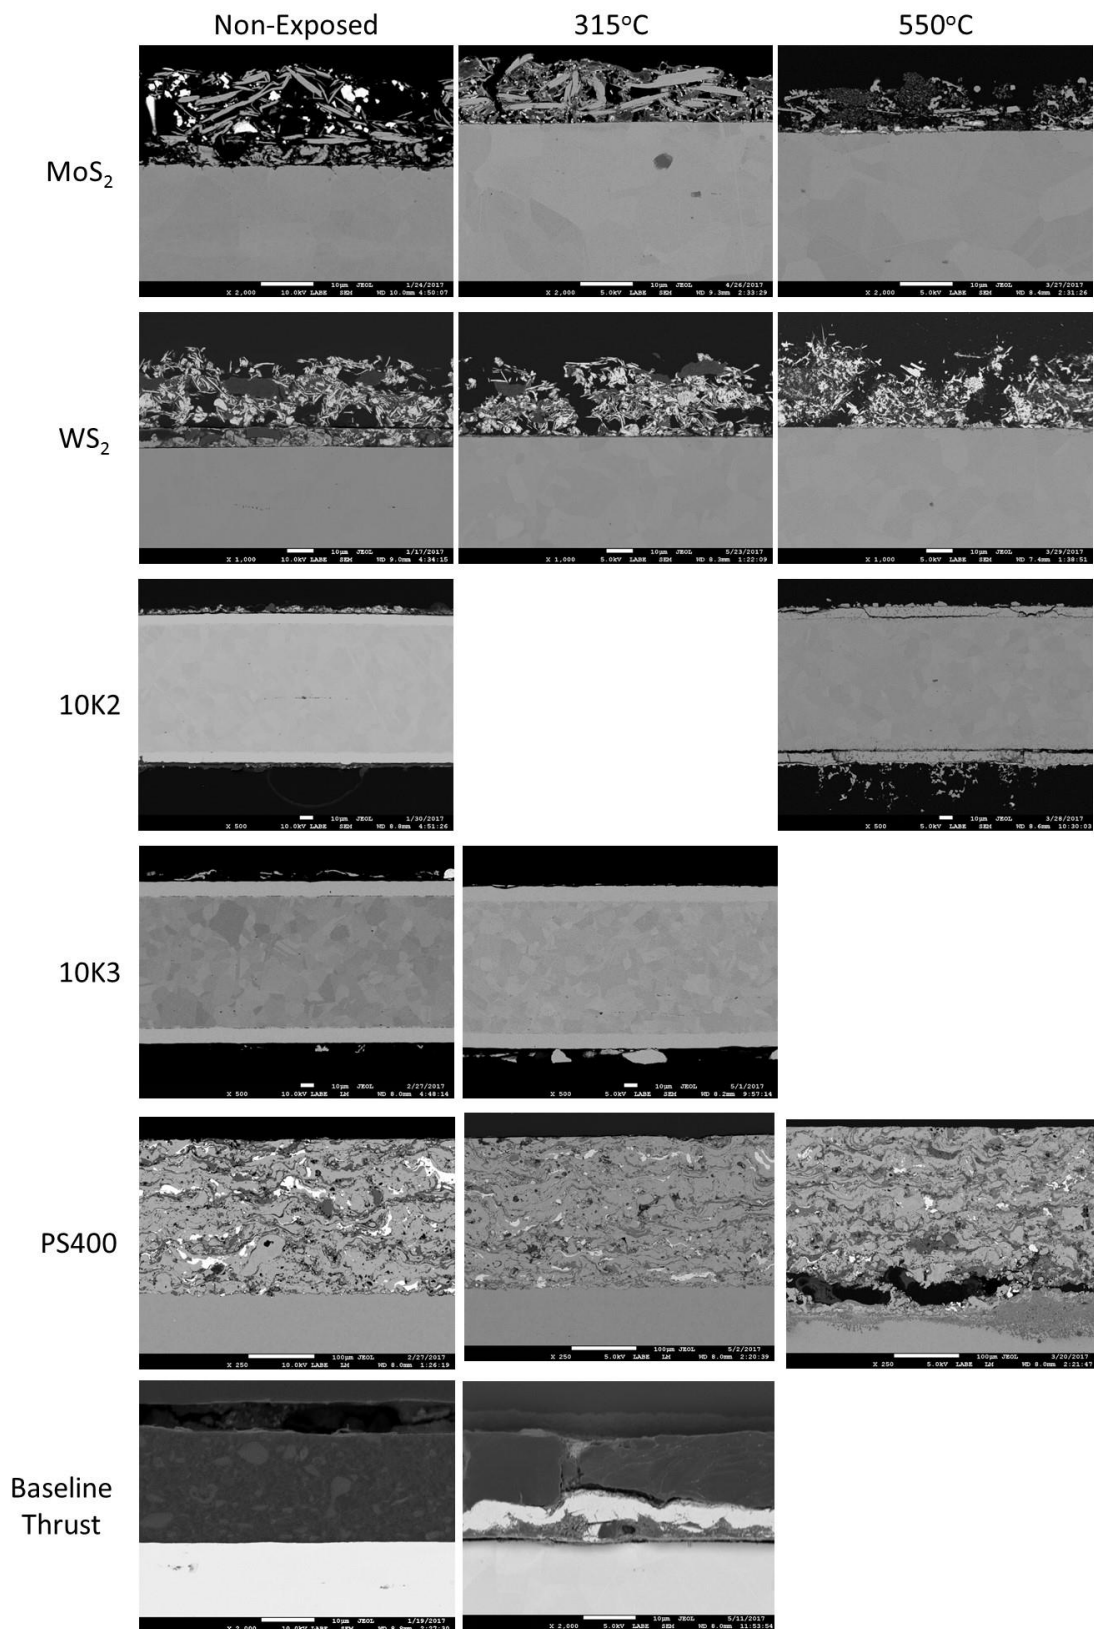
Figure 24. SEM cross-sections for one set of samples compared for the three conditions

The most notable general observation for all of these samples, is that the lower temperature exposure resulted in relatively minor microstructural changes, while the higher temperature resulted in rather dramatic changes for many of the materials. An exception to this was the baseline thrust bearing foil sample which was observed to be severely degraded by the lower temperature exposure. Another exception was for both the MoS₂ and WS₂ samples, which didn't exhibit significant microstructural change at either exposure temperature.

Some samples exhibited extensive microstructural damage, which may preclude them from future consideration/testing as a bearing foil coating material. For the 315°C environment, the analysis suggests that the TX1 samples be eliminated from consideration. Chemical analysis of the corrosion products on the TX1 material is shown in Figure 26. While the nitrogen is still found near the surface and may be able to impart the desired hardness and wear resistance, an iron-based oxide is found on the surface that could spall and contribute to particulate generation within the bearing. The baseline thrust bearing coating also exhibited severe microstructural damage at the lower temperature. This may be attributable to a testing temperature above that which the bearing actually sees, since the degradation observed in this test was much more severe than is typically observed for these bearings. Nonetheless, it is good to know that other bearing coating materials are available that can tolerate this 315°C exposure temperature without the same degradation.

For the 550°C environment, several of the samples could be eliminated from consideration based on the severity of the microstructural damage observed. The TX1 sample oxidation, that was a problem at the lower temperature, was even more problematic at this higher temperature. Chemical analysis of the corrosion products on this sample are shown in Figure 27. The oxide is now much thicker and consists of an inner chrome-oxide layer and outer iron-oxide layer. This material should be eliminated from consideration in bearing foils at both of the exposure conditions. Also, the 10K2 coating is not recommended for use at this temperature due to coating delamination from the foil substrate. Chemical analysis of this coating is shown in Figure 28. The substrate surface was observed to be depleted in chromium, as a precipitated Cr-S phase was found within the Ni-P coating layer. This may have contributed to the coating delamination that was observed. Also, islands of a Ni-S phase were found on top of the coating surface, which may contribute to increased surface roughness.

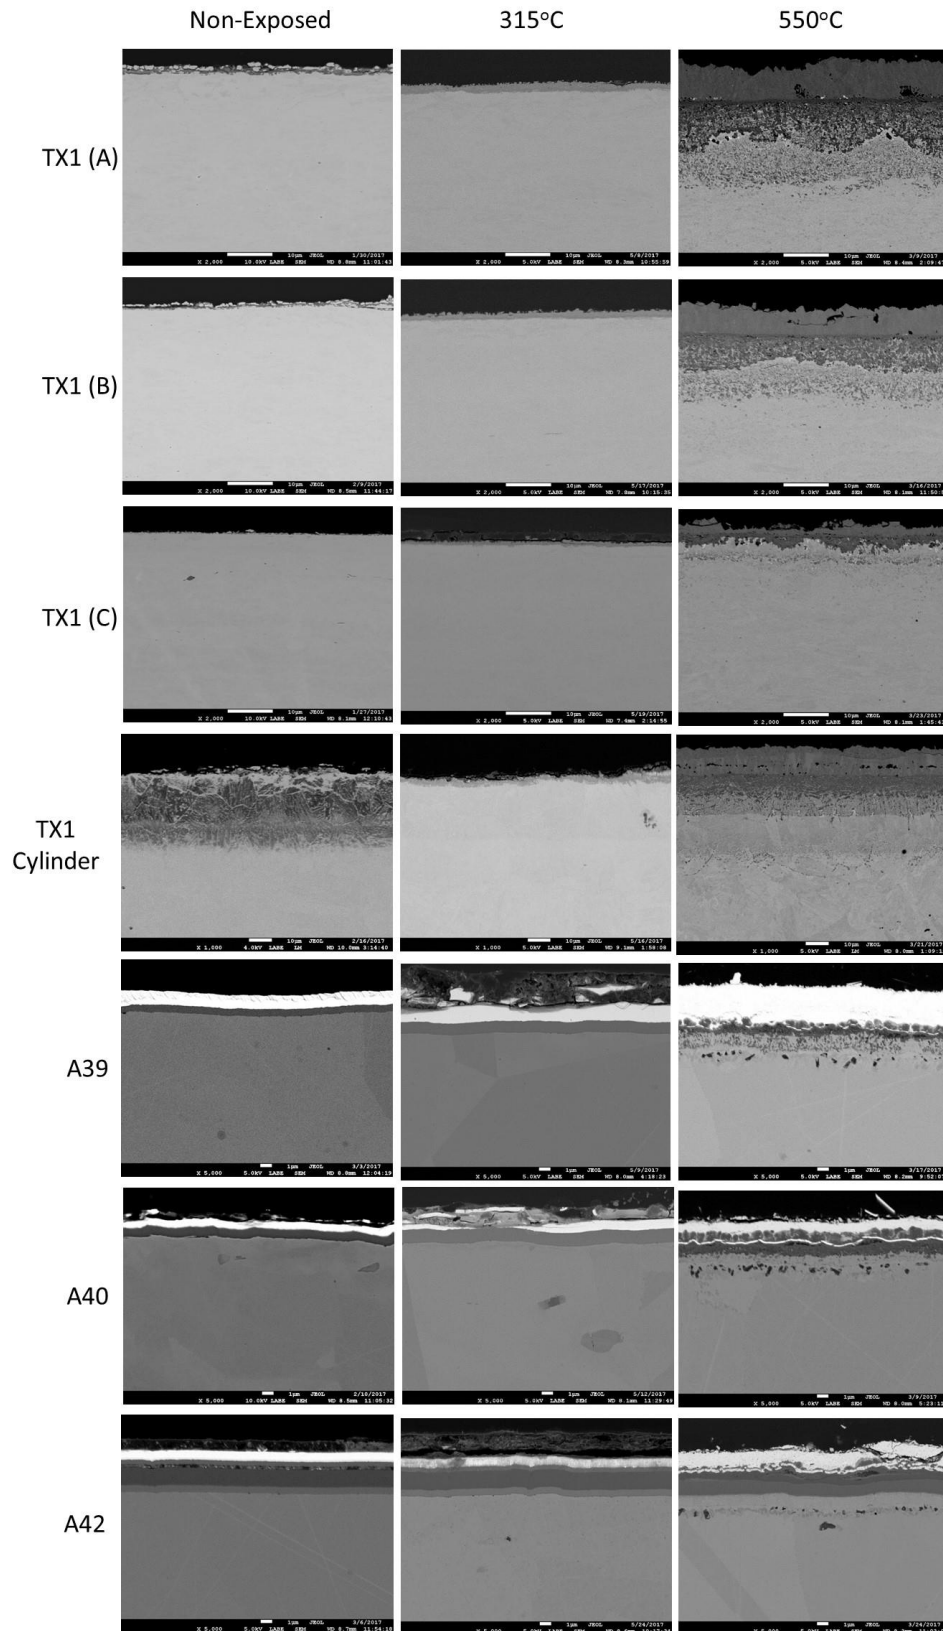
Figure 25. SEM cross-sections for a second set of samples compared for the three conditions

Microstructural degradation was observed for both the PS400 as well as the Mechanical Solutions samples (A39, A40, A42) at the higher temperature, but neither should be precluded from future consideration based on this. In the case of the PS400, the coating material itself did not change. Instead, oxidation was observed to occur at the coating-substrate interface. A chemical analysis of the coating-substrate interface is provided in Figure 29, which shows the formation of iron-oxide at the interface. This is partially attributable to the substrate material, rather than to the coating. The PS400 was applied to a 15-5 stainless steel substrate, which is significantly more susceptible to corrosion in CO₂ environments than for the Inconel X750 substrates used with many of the other coatings. One could argue that the MoS₂ or WS₂ samples, which also did not exhibit obvious degradation of the coating material, would have demonstrated similar substrate oxidation as the PS400 if they had been put down on the 15-5 alloy rather than X750.

In the case of the three Mechanical Solutions coatings, they all appear to change following the high temperature exposure. It appears that the coating material either reacts with the substrate alloy or there is internal oxidation that occurs below the surface of the substrate. The coating material itself appears to remain intact and may indeed function well as a bearing coating. Due to the NDA that is established with them, the authors are unable to provide any additional information regarding the chemistry of the coating itself or any of the reaction products.
